## PRODUCT UPDATE

**TO:** ALL SIERRA CUSTOMERS AND SALES PROFESSIONALS  
**FROM:** MIKE CRITES  
**DATE:** November 8, 2016  
**RE:** 18-3160-1 Product Updates

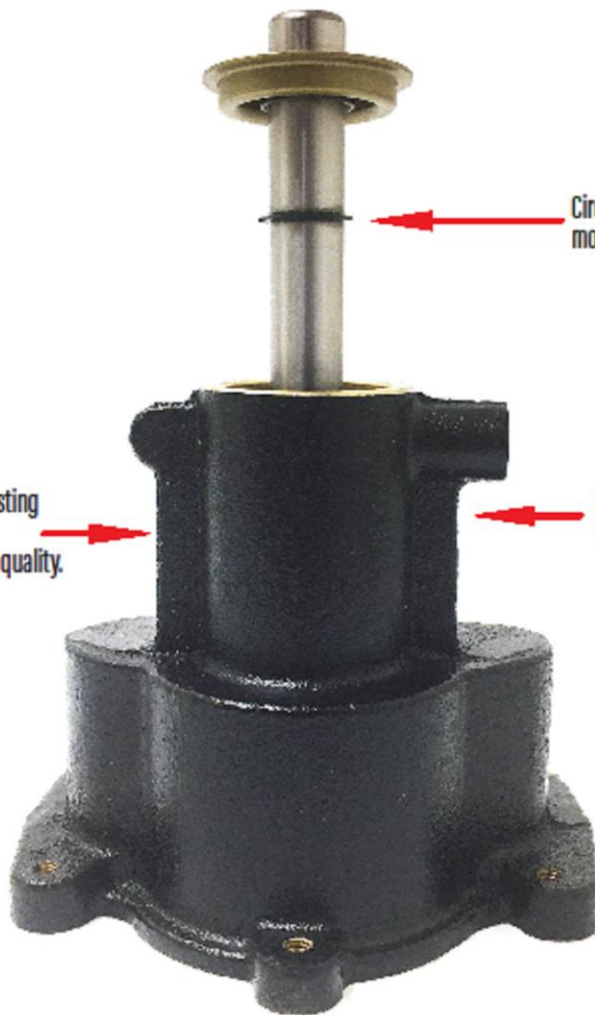
100% leak inspected after casting  
and random testing prior to  
shipping ensures consistent quality.

Circlip helps to prevent shaft  
movement during pulley installation

Vacuum impregnating casting  
process prevents leaks.

- Housing casting now manufactured using a Vacuum Impregnating process that prevents possible leakage from the brass casting.
- All housings after casting and machining are 100% pressure and vacuum tested for leakage. Prior to shipping from our Litchfield facility a random inspection sample, of *not less than 10%* of the shipment, is again tested for leaks and visually inspected. Any parts that fail to pass the random testing triggers a 100% inspection of all parts on that shipment.

- A circlip has been added to the pulley shaft to help prevent movement of the shaft if the pulley is not installed with the proper installation tool. Movement of the shaft during improper pulley installation has shown to result in water leakage at the seal and possible diminished cooling capacity.

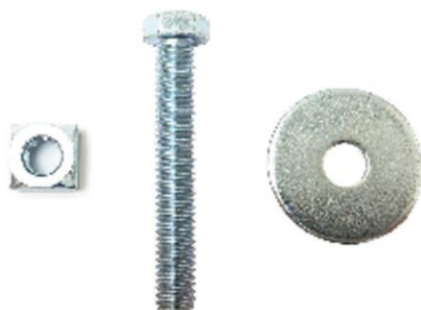
Pulley installation kit ensures  
proper fit and prevents damage to  
shaft seal.

- The pump now includes a pulley installation tool and installation guide.
  - **NOTE:** To avoid possibly voiding the warranty, the pulley should only be installed utilizing the now included tool and following the installation guide instructions. A shop press should never be used to install the pulley even if the pump shaft is supported to avoid possible shaft movement and seal damage.

- Pulley installation tool and installation guide are now included with the part.
